# **STRUCTURAL INTEGRITY ASSESSMENT**

Deferiet Paper Mill Site  
400 Anderson Avenue  
Deferiet, New York

**March 2021**

## STRUCTURAL INTEGRITY ASSESSMENT

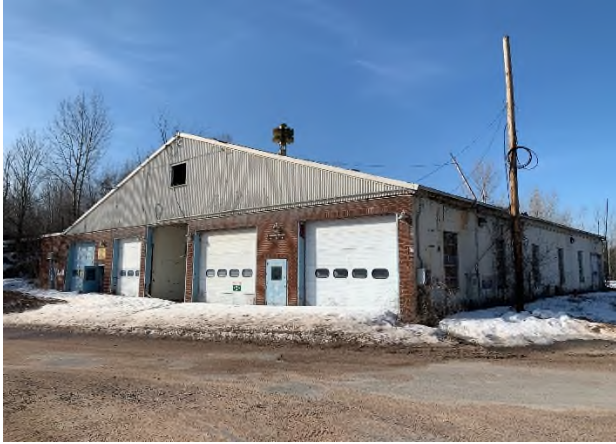
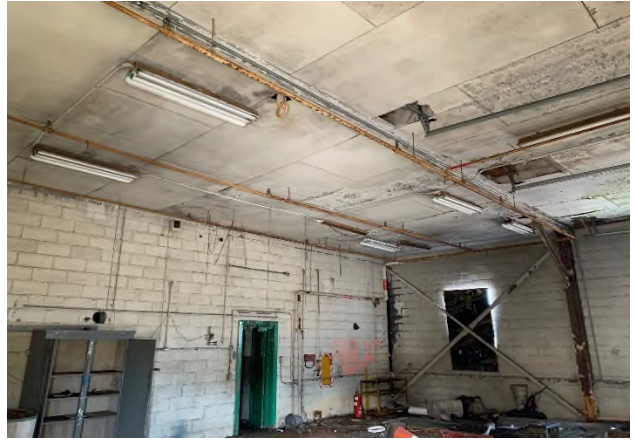
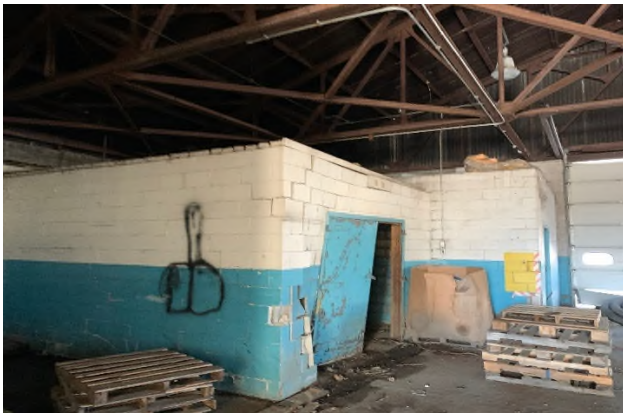
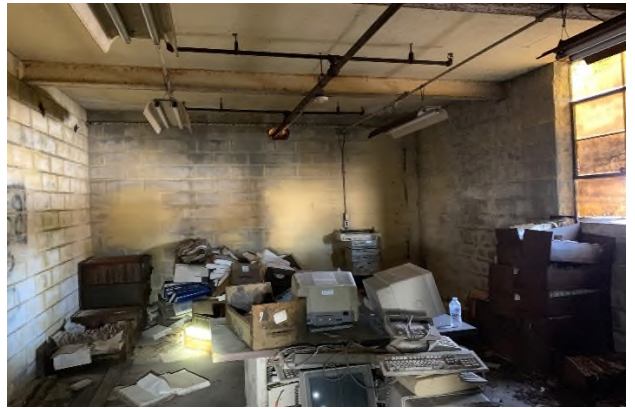
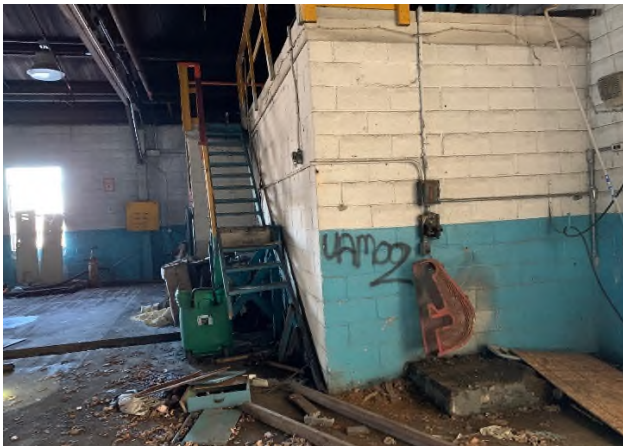
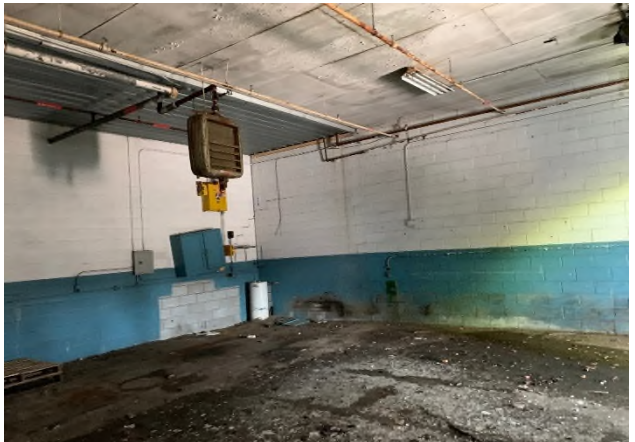
## Company Garage

The Company Garage is a single-story concrete block/brick and steel support structure of approximately 10,000 square foot in size. Based on inspection of the building, there was no significant change from the previous inspection and the structure is in generally good condition with no obvious structural integrity issues observed. Therefore, it is NEU-VELLE's judgement that safe removal of bulk or loose asbestos and/or encapsulation could be accomplished in this area. However, there is an interior masonry block room constructed within the building which shows signs of failing (shifting joints and blocks). Any work within or near this interior room should not be conducted and care should be taken if working in the area.

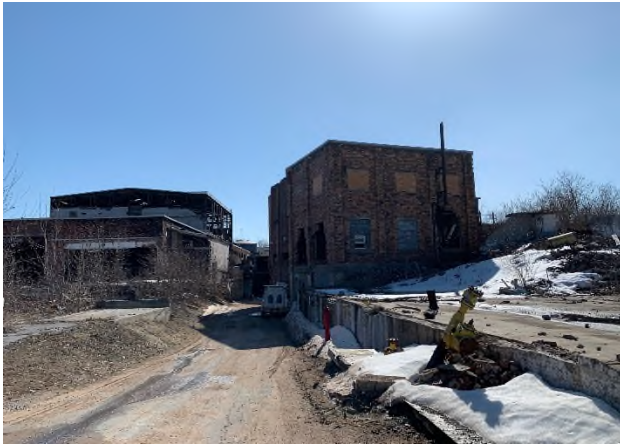
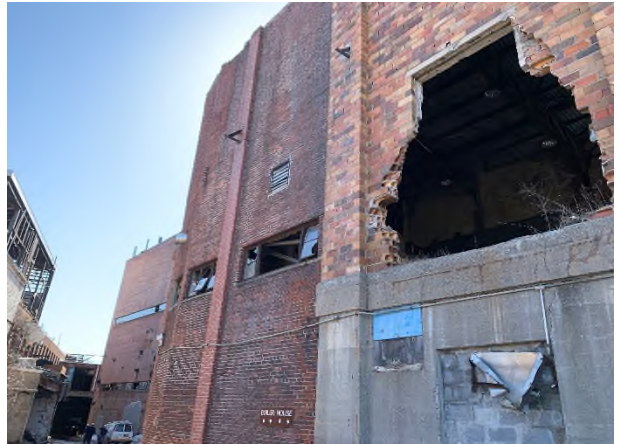
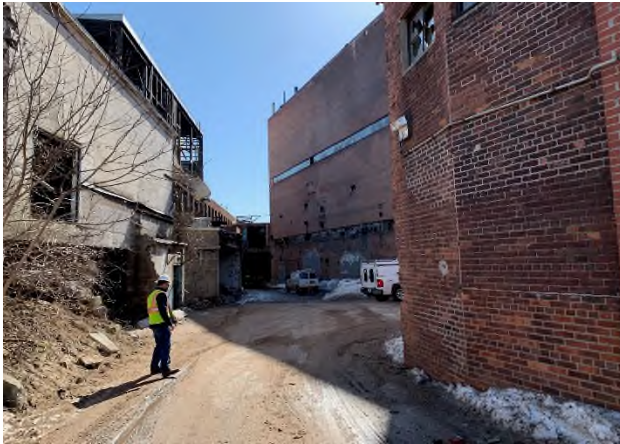
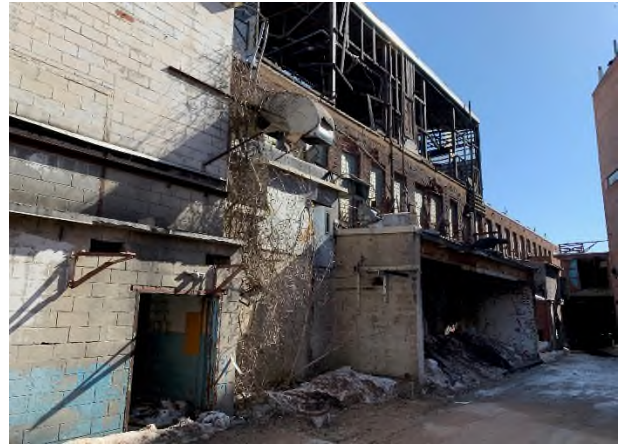
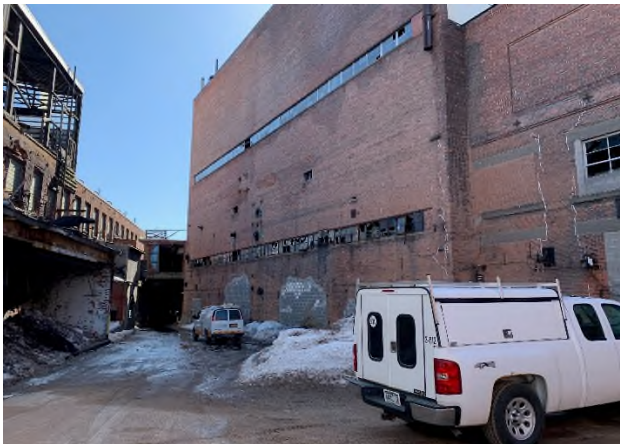
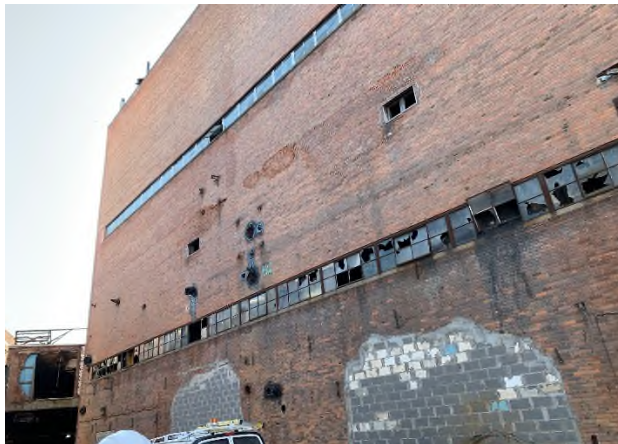
## Easement

As indicated previously, the site currently has an active hydroelectric plant which is operated by Brookfield Renewable Power, LLC. An access route to the Brookfield plant is provided by an easement area that runs approximately north to south through the plant site. Based on inspection of the easement area, there was no significant change from the previous inspection and the structures are in generally good condition with no obvious exterior structural integrity issues observed. Therefore, it is NEU-VELLE's judgement that safe removal of bulk or loose asbestos and/or encapsulation could be accomplished in this area. However, care should be taken in areas of loose brick on various areas of the structures during work activities.

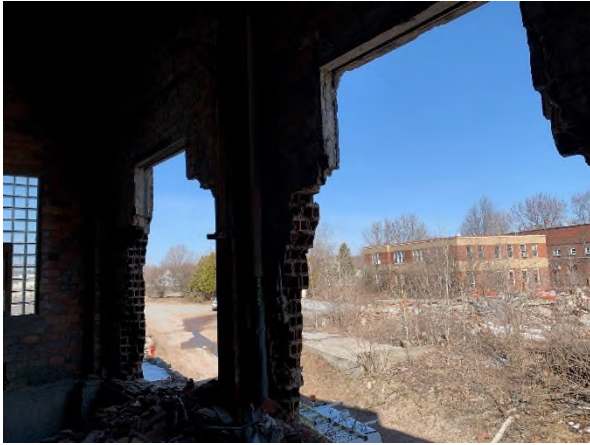
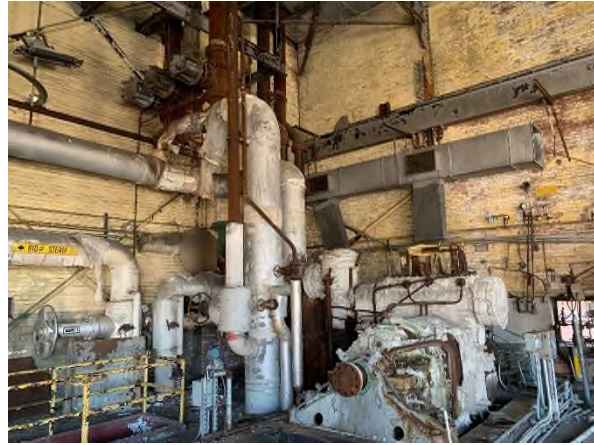
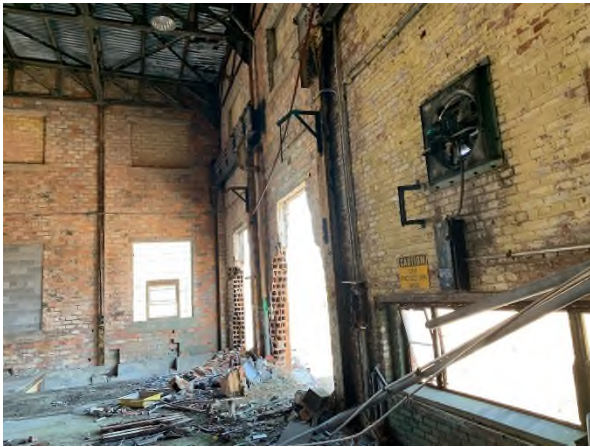
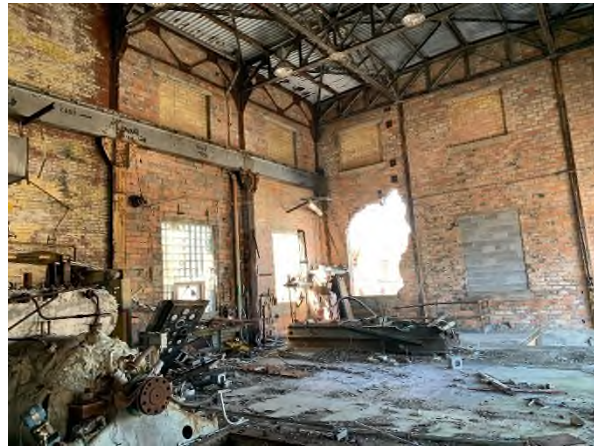
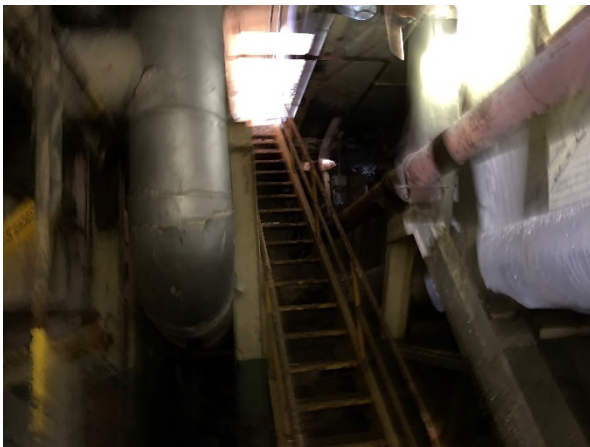
## Turbine Room

The Turbine Room is a multi-story brick and steel support structure of approximately 6,000 square foot in size. Based on inspection of the building, there was no significant change from the previous inspection, and the structure is in generally good condition with no obvious structural integrity issues observed other than that there has been brick removed on the second floor of the structure to apparently gain access to the interior of the structure for equipment removal. It is NEU-VELLE's judgement that safe removal of bulk or loose asbestos and/or encapsulation could be accomplished in this building as long as care is taken in areas where there is loose brick/block, overhanging equipment (i.e., piping, etc.), and floor openings.

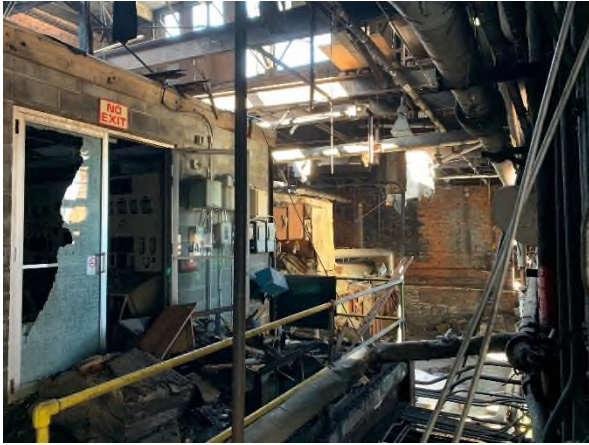
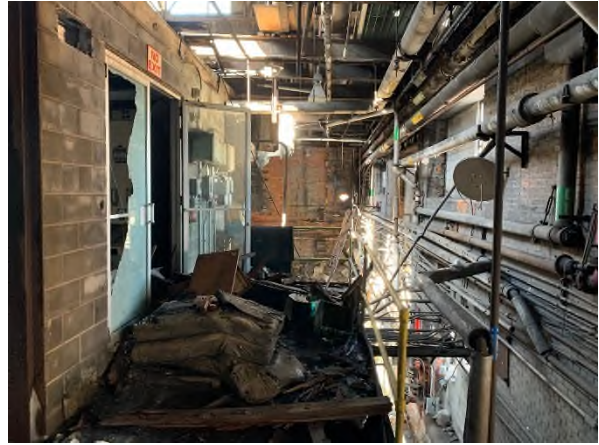
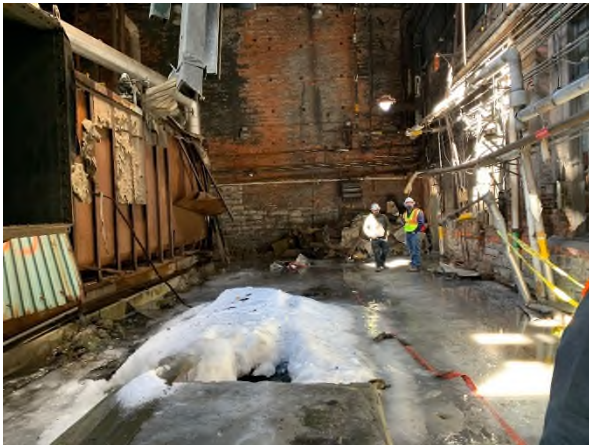
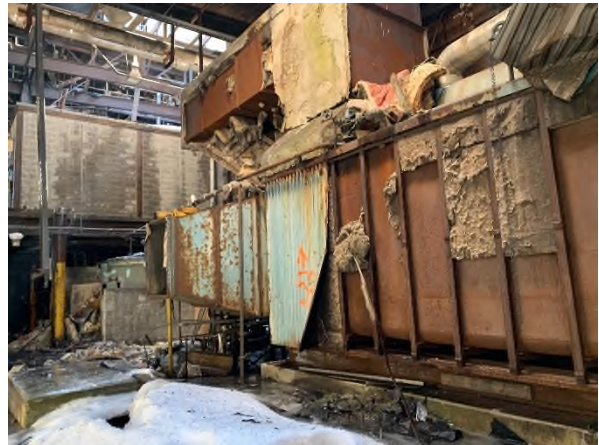
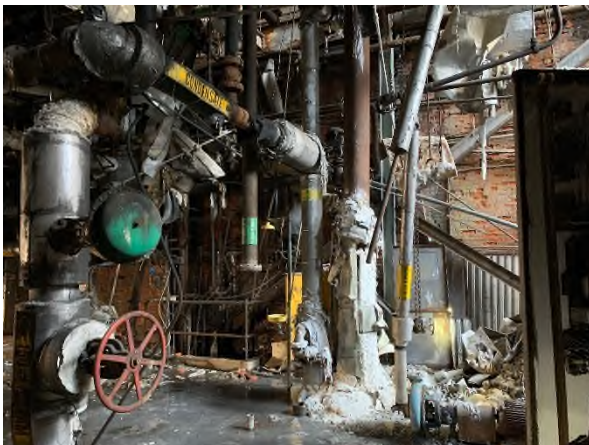
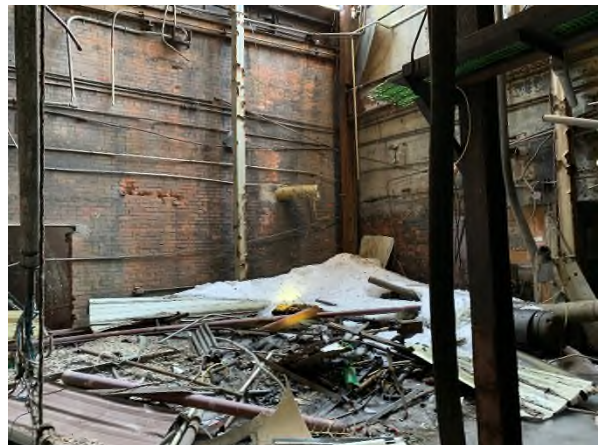
## Boiler Room

The Boiler Room is a multi-story brick and steel support structure of approximately 32,000 square foot in size. Based on inspection of the building, there was no significant change from the previous inspection and the structure is in generally good condition with no obvious structural integrity issues observed other than areas of loose brick throughout the structure. Therefore, it is NEU-VELLE's judgement that safe removal of bulk or loose asbestos and/or encapsulation could be accomplished in this building as long as care is taken in areas where there is loose brick/block, overhanging equipment (i.e., piping, etc.) floor openings.

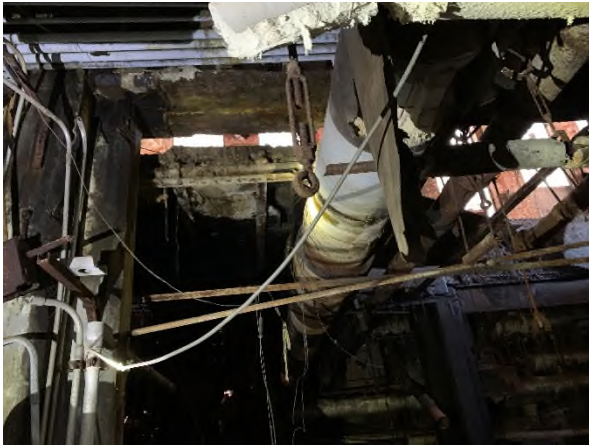
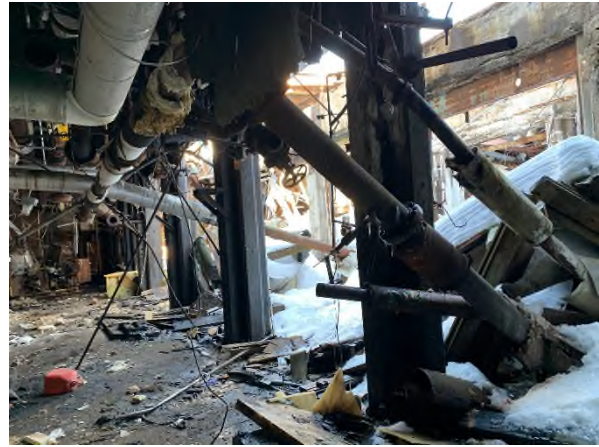
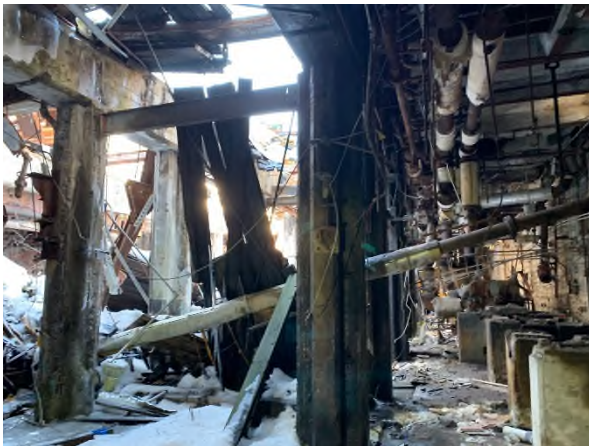
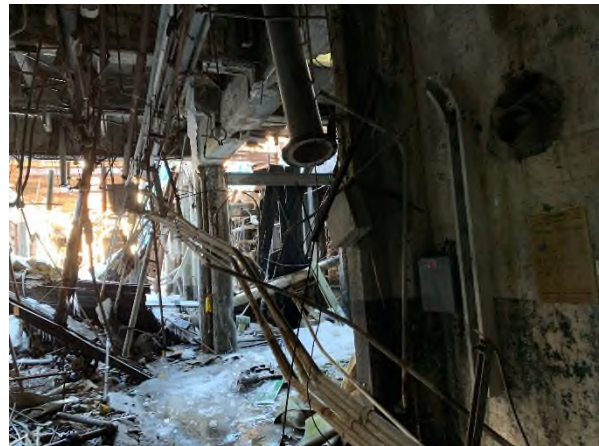
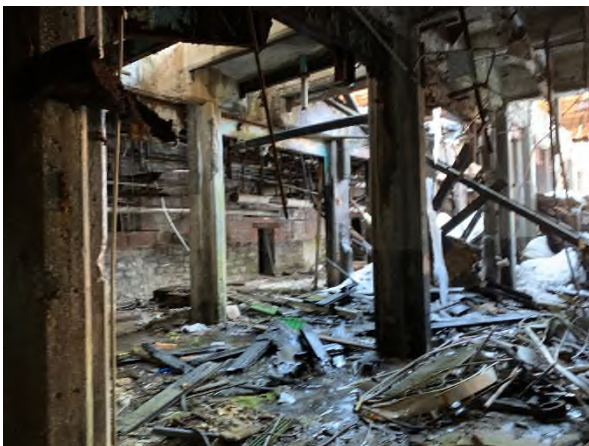
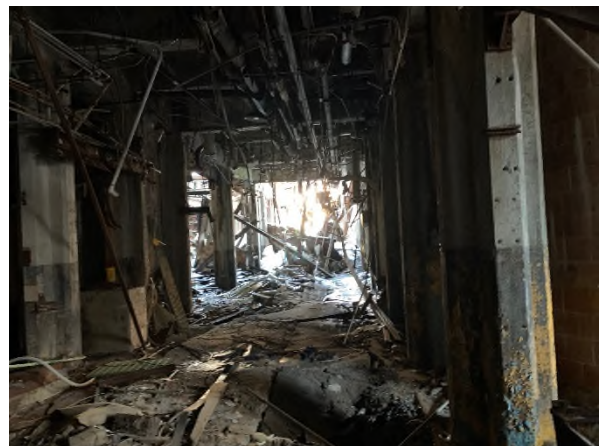
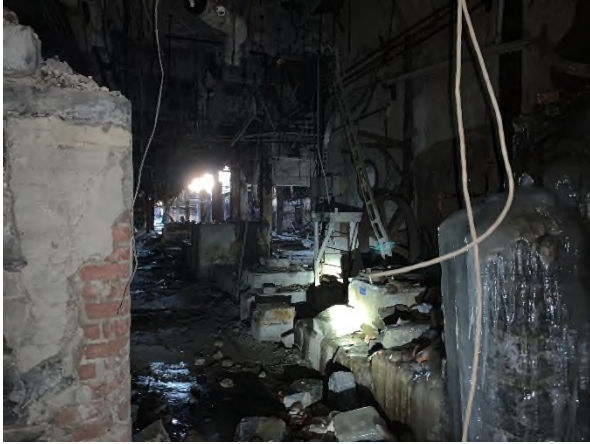
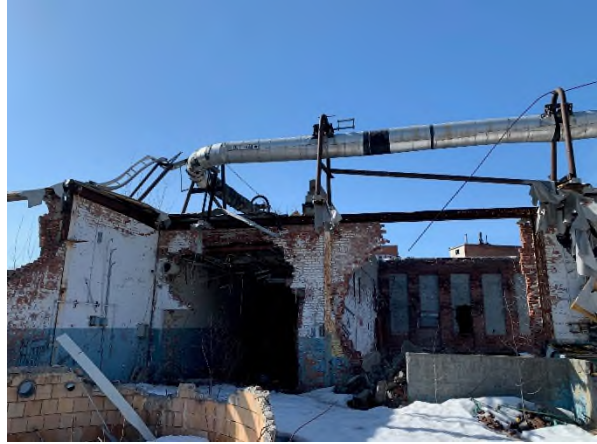
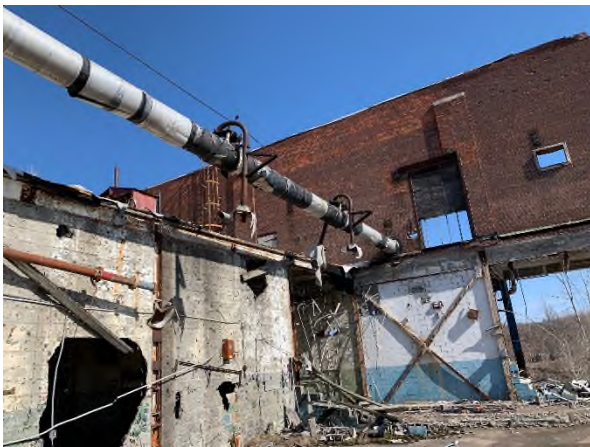
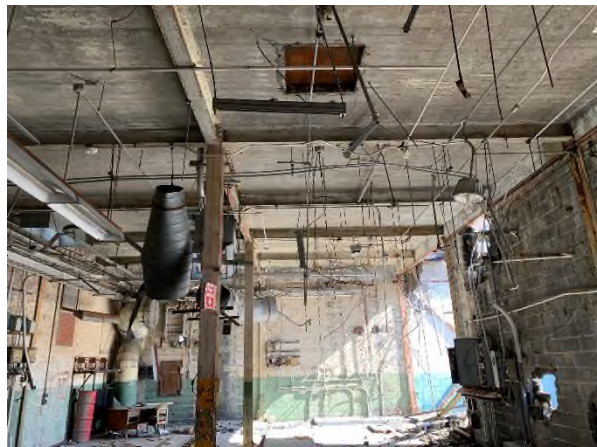
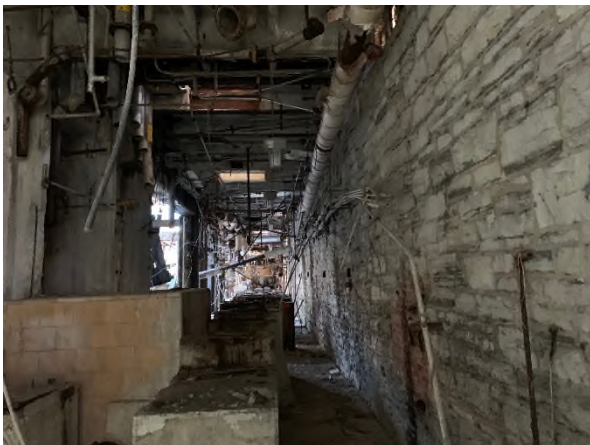
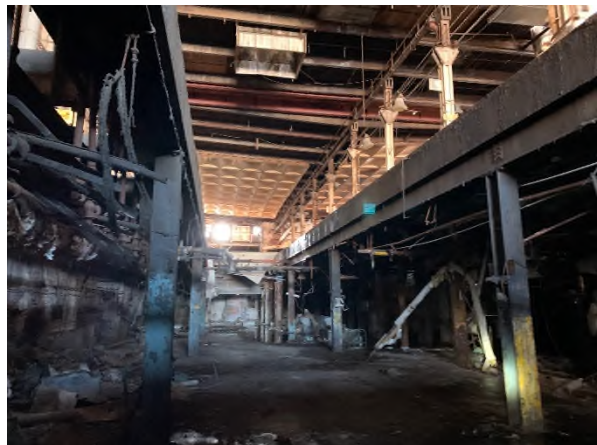
## Machine/Equipment Rooms

The Machine Room is a mainly one-story brick and steel support structure of approximately 25,000 square foot in size. Based on inspection of the building, there was no significant change from the previous inspection and the structure is in generally good condition with no obvious structural integrity issues observed other than areas of loose brick/block throughout the structure. Therefore, it is NEU-VELLE's judgement that safe removal of bulk or loose asbestos and/or encapsulation could be accomplished in this building as long as care is taken in areas where there is loose brick/block or overhanging equipment (i.e., piping, etc.).

The Equipment Room is a multi-story brick and steel support structure of approximately 25,000 square foot in size. Based on inspection of the building, there was no significant change from the previous inspection and the structure is in generally good condition with no obvious structural integrity issues observed other than the area has undergone demolition activities and areas of the building are collapsed. In addition, there are portions of the second floor that have deteriorated and should be supported if working in the vicinity of these areas. Therefore, it is NEU-VELLE's judgement that safe removal of bulk or loose asbestos and/or encapsulation could be accomplished in this building as long as care is taken in areas where there is loose brick/block, collapsed roof and/or floor structures, or overhanging equipment (i.e., piping, etc.).

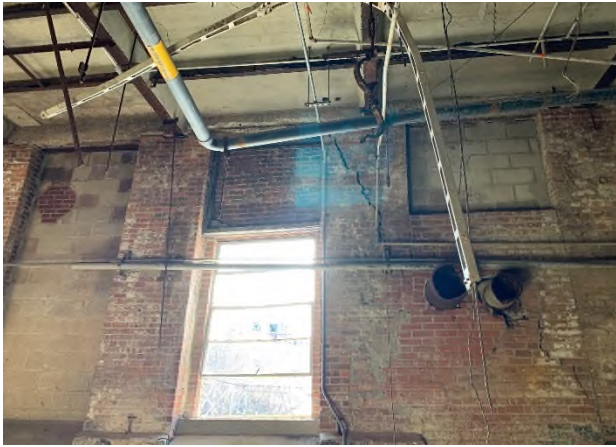
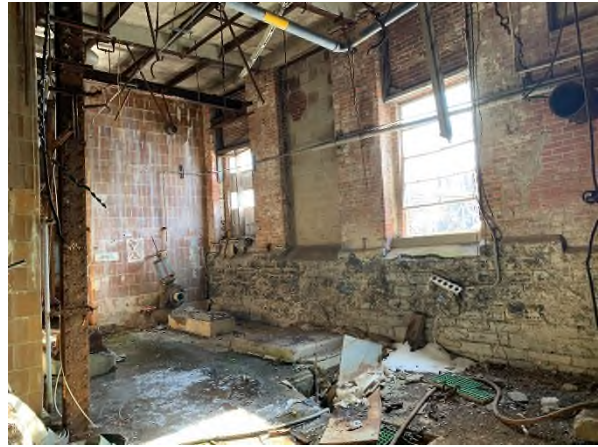
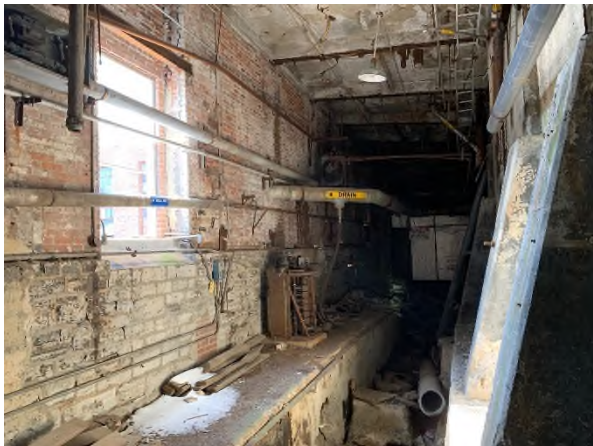
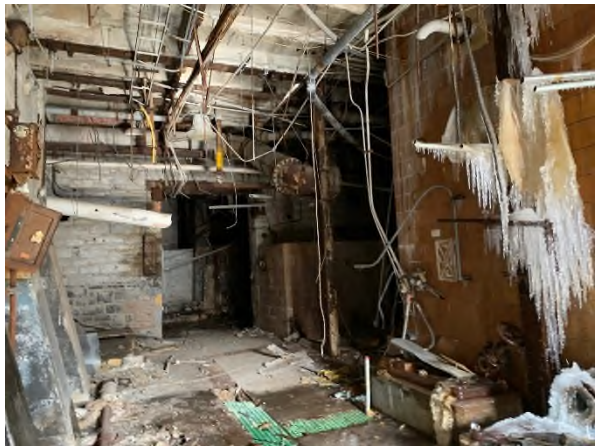
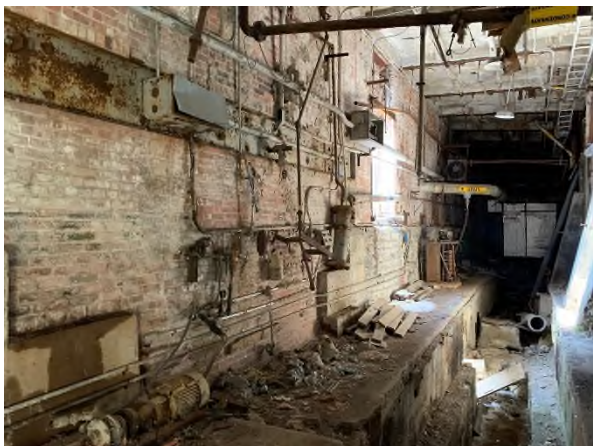
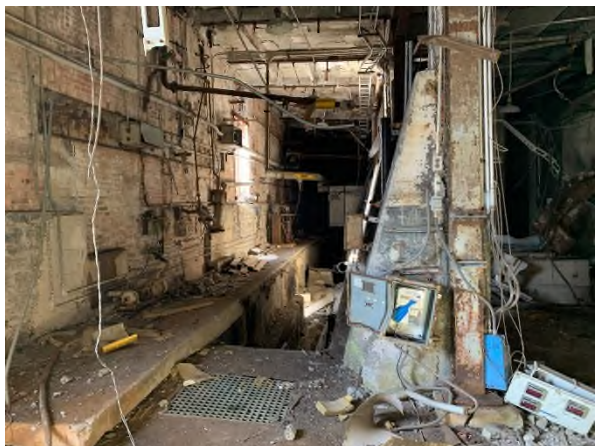
## Wet/Beater Room

The Wet/Beater Room is a one-story brick and steel support structure of approximately 30,000 square foot in size. It is located adjacent to the Brookfield Renewable Power which shares a common wall with this area/room. Based on inspection of the building, there was no significant change from the previous inspection and the majority of the structure is in generally good condition with no obvious structural integrity issues observed. However, the wall adjacent to the Canal shows significant signs of foundation deterioration in the area just adjacent to the power plant. Based on previous discussions from Brookfield Renewable Power representatives, significant settlement and deformation of the foundation has been observed (underwater visual inspection, etc.). Therefore, it is NEU-VELLE's judgement that safe removal of bulk or loose asbestos and/or encapsulation should not be conducted within 50 feet of this wall. In addition, based on inspection of the foundation in this area, NEU-VELLE does not believe that temporary shoring and/or supports should be used to protect the structure from collapse. It is recommended that a thorough underwater inspection of the foundation be conducted to design a remedy for this area, or it be properly raised. However, other areas of the building can be safely entered as long as care is taken

in areas where there is loose brick/block, collapsed roof and/or floor structures, or overhanging equipment (i.e., piping, etc.).

However, it is NEU-VELLE's judgement that the Wet/Beater Room wall adjacent to the Brookfield Power Plant is not safe and work should not be conducted within 50 feet of this wall. In addition, based on inspection of the foundation in this area, NEU-VELLE does not believe that temporary shoring and/or supports should be used to protect the structure from eventual collapse. It is recommended that a thorough underwater inspection of the foundation be conducted to design a permanent remedy for this area, or it be properly raised.

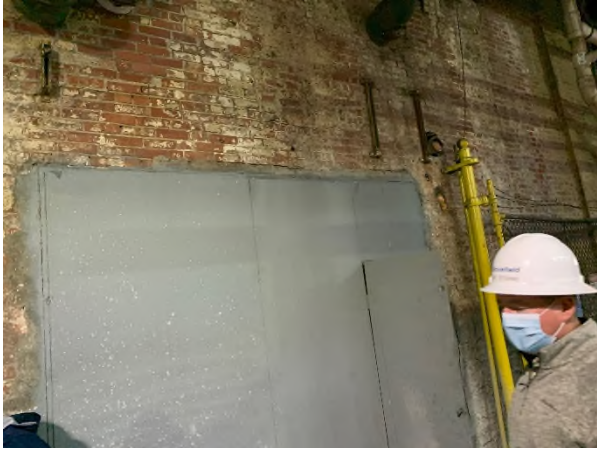
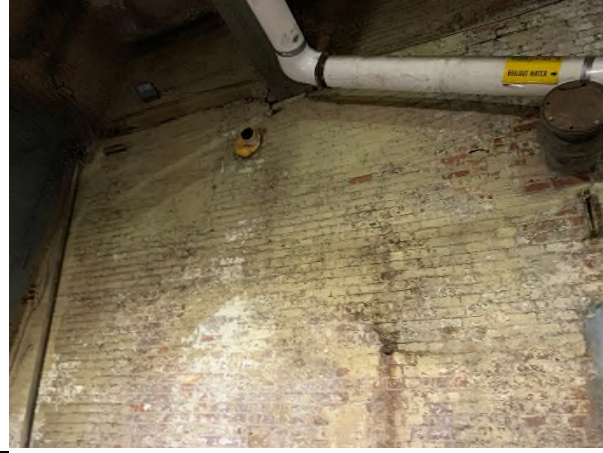
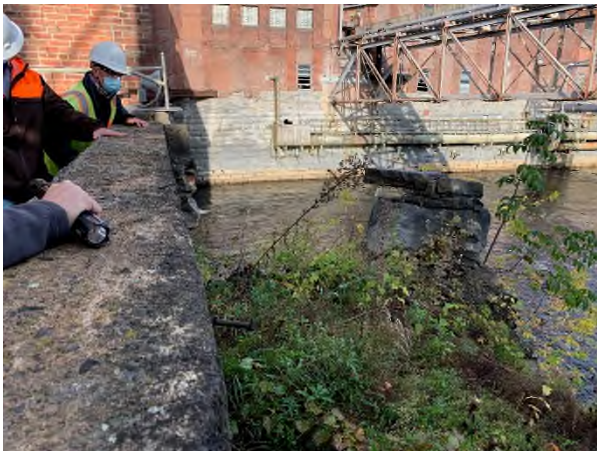
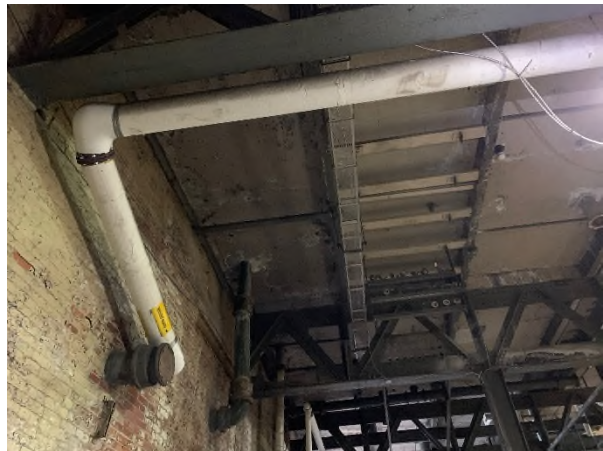
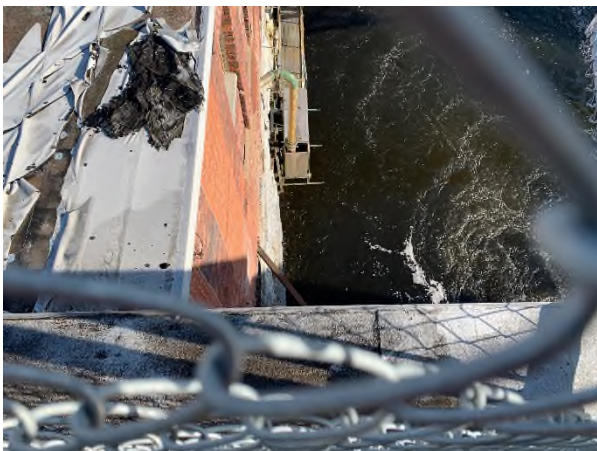
**Brookfield Building & Shared Walls**  
**(Photos from October 14, 2020)**

The Brookfield Renewable Power Plant building is a multi-story brick and steel support structure of approximately 15,000 square foot in size. It is located adjacent to the Wet/Beater Room. Based on inspection of the building (inspection was only conducted from the Wet/Beater Room), there was no significant change from the previous inspection and the structure is in generally good condition with no obvious structural integrity issues observed. In addition, the common wall between the plant and the Wet/Beater appears to be in generally good condition with no apparent structural issues. However, as indicated above, the wall adjacent to the Canal shows significant signs of foundation deterioration in the area just adjacent to the power plant. In the event that this wall's foundation becomes increasingly compromised, failure of the Wet/Beater Room wall could occur and compromise the structural integrity of the Brookfield Renewable Power Plant. Therefore, it is recommended that a thorough underwater inspection of the foundation be conducted to design a remedy for this area, or it be properly raised.
